GOAA Sustainability Speaker Series ANATOMY OF A RUNWAY REHABILITATION

Rehabilitation of North Airfield Pavement & EMAS Beds

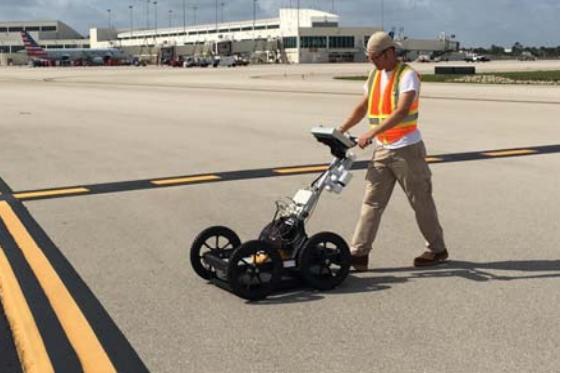
Ground Penetrating Radar

Nondestructive Testing (NDT)

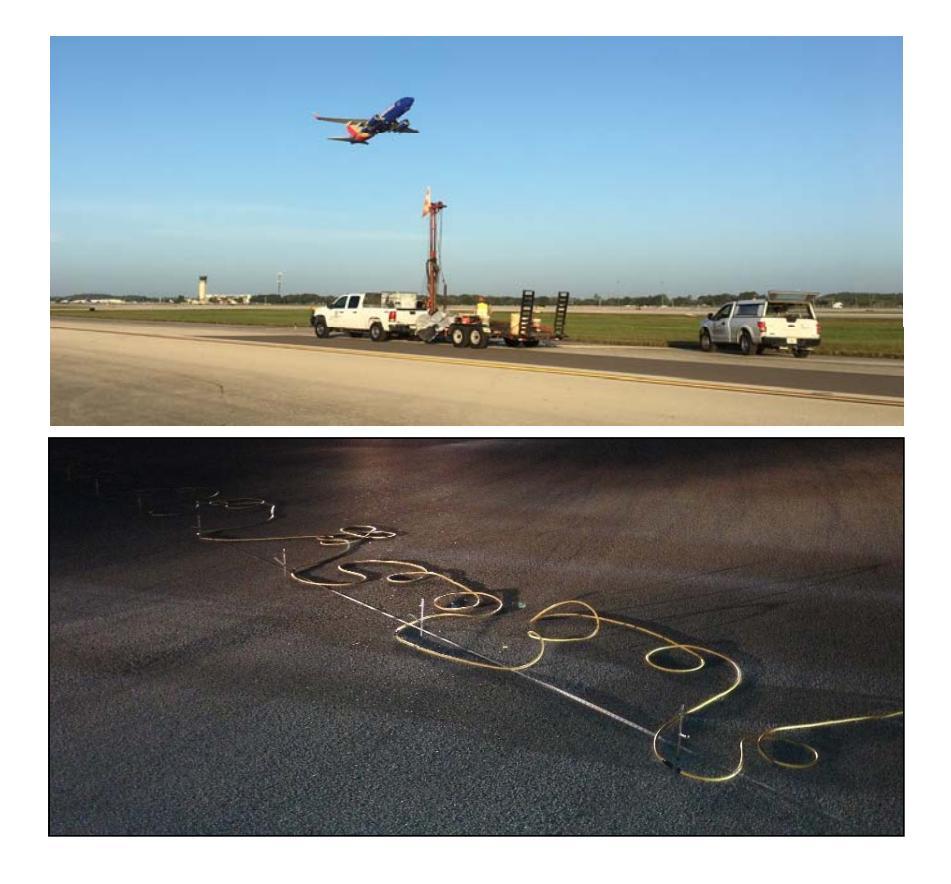
Additional Subsurface Investigation

In areas where karst features may be present, additional destructive testing is required to confirm.

- Deep soil boring
- Electrical Resistivity Imaging (ERI)

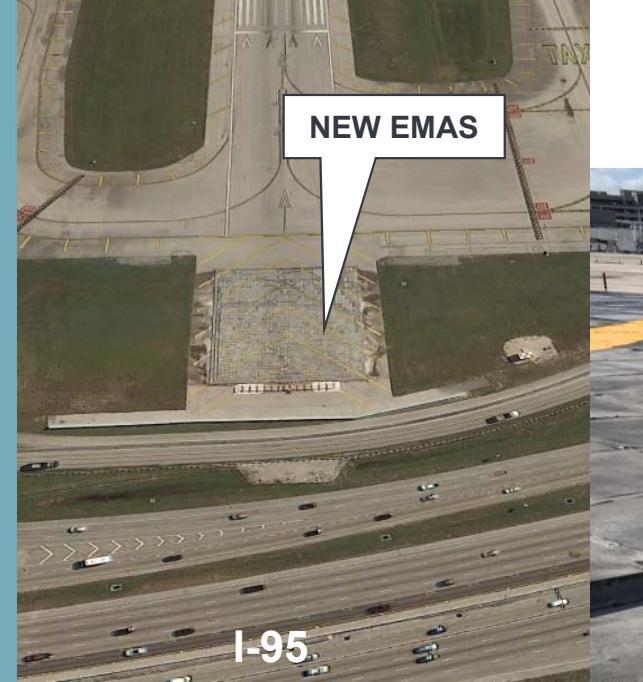
Engineering Material Arresting Systems (EMAS)

- The EMAS technology improves safety benefits in cases where land is not available, or it's not possible to have the standard 1,000-ft overrun.
- An EMAS arrestor bed can help slow or stop an aircraft that overruns the runway.

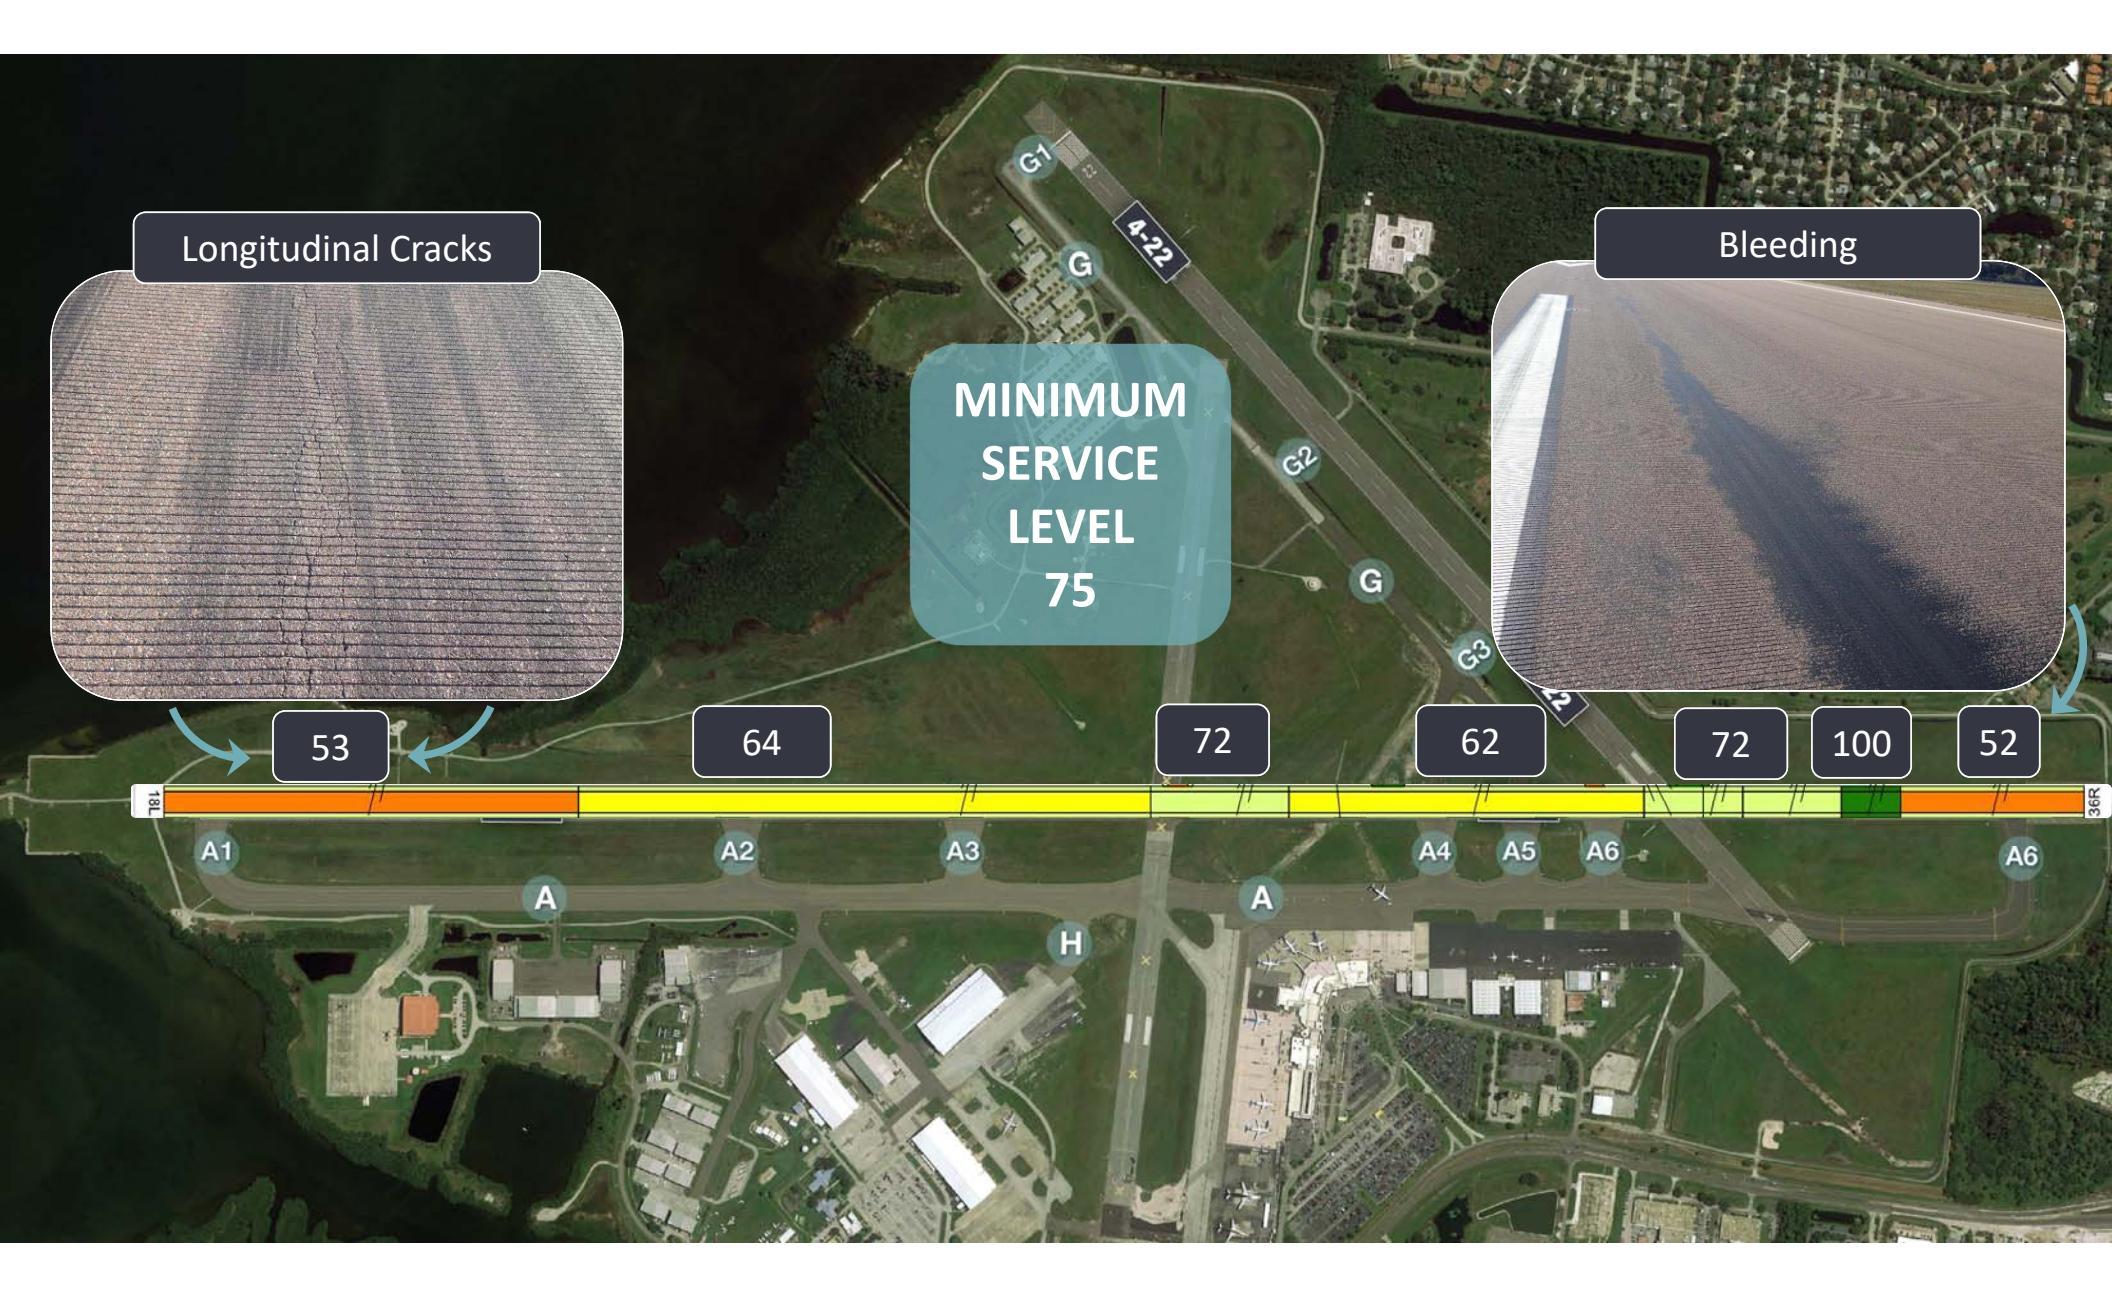
the second second	2	019 Predicted PCI = 45 Poor	Ser all the
	Network ID	PIE	
	Branch ID	RW 18-36	
C. / J. P.	Branch Name	RUNWAY 18-36	ALL AND ALL AN
	Branch Use	RUNWAY	The states of
	Section ID	6197	
	Section Area (SF)	92,900	
	Surface Type	AC	
	Last Major Work Date	1/1/2006	
	Years Since Major Work	12.2	
	Last Inspection Date	1/30/2015	
	PCI (2014)	52	Charles Mars
	PCI Category (2014)	Poor	
	PCI % Climate	23	a long and the
	PCI % Load	0	
	PCI % Other	77	
	2014 Distresses Observed	Bleeding, Longitudinal & Transverse Cracking and Weathering	· ····································
	Predicted PCI (2019)	45	
	Predicted PCI Category (2019)	Poor

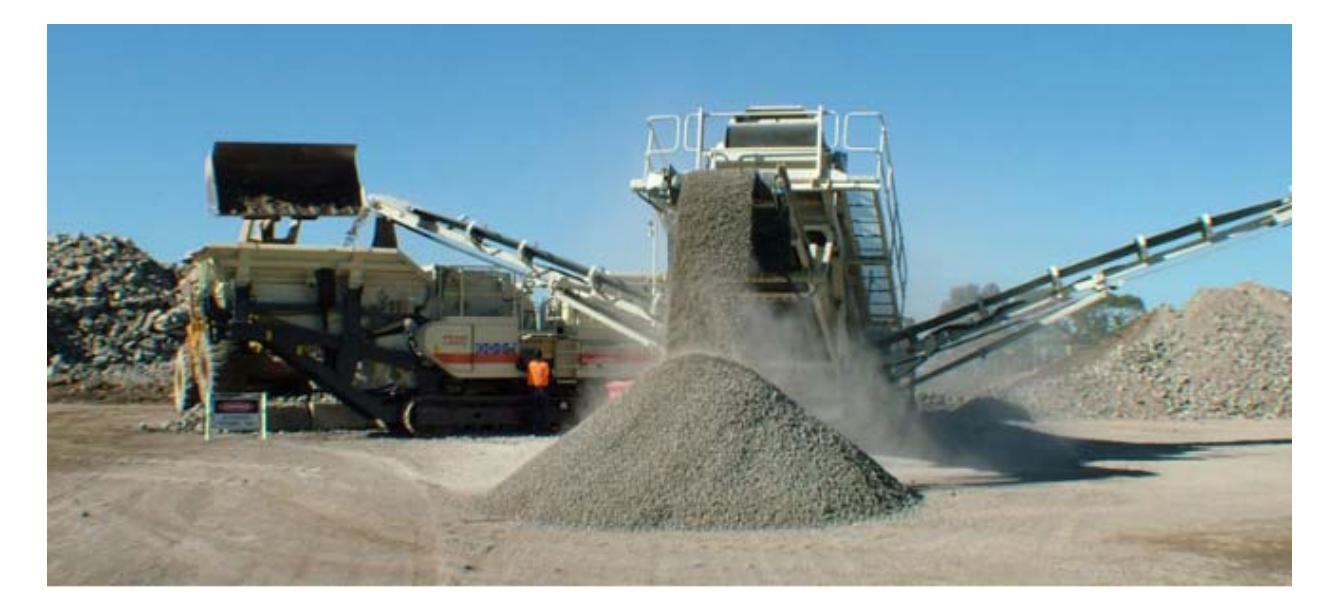
Opportunities for Sustainability

- Use of Recycled Concrete Base Course (FAA Specification P-219)
- In-place pulverization

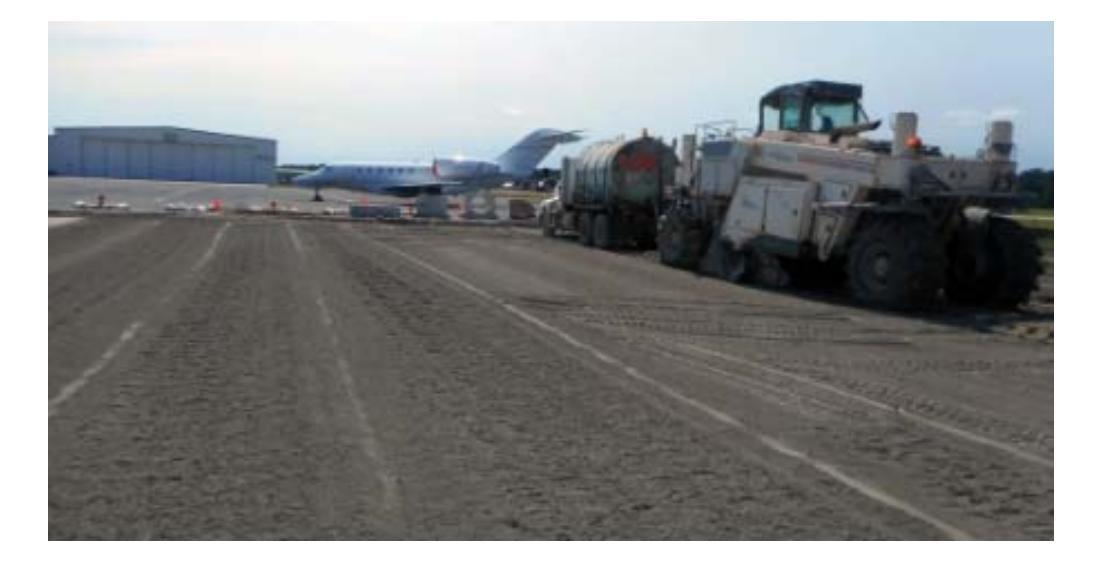
Opportunities for Sustainability

- Full-Depth Reclamation
 - Reconstruction method that pulverizes asphalt surface and combines with underlying aggregate base
 - 60,000 lbs or less ⊗
